MicroXRF analysis of the ancient icons

XROS MF30 – laboratory x-ray microscope-microprobe for studies of the objects by the methods of the optical microscopy, radiography, local element XRF microanalysis with possibility of the element mapping. Using a microscope, a sample of up to 400 mm in size along the Y axis and of unlimited size along the X axis (max. scan area 150×150 mm; in the case of a larger area, the scanned areas can be stitched) and up to 105 mm high can be performed.

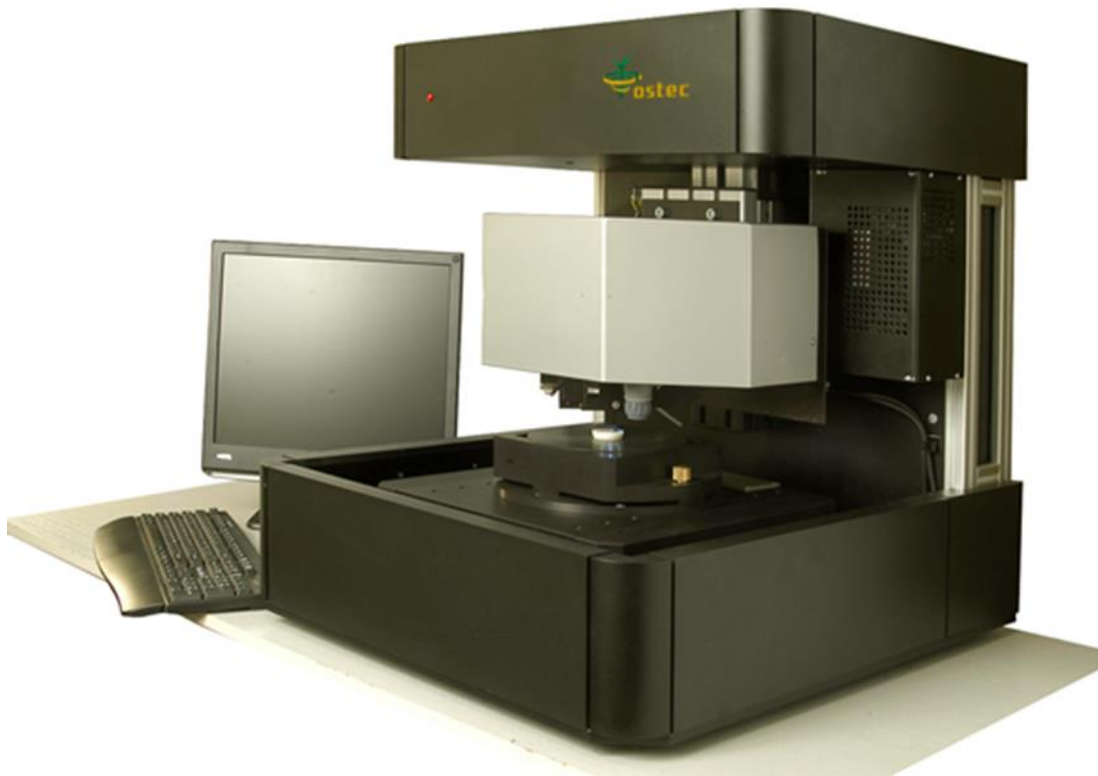
An overview video camera and two optical microscopes with magnification up to 200 times are using for accurate determination of the scanning area.

The central optical microscope with automated sharpness adjustment is combined with the axis of the microprobe (axis of the x-ray beam).

Local X-ray fluorescence microanalysis with the possibility of elemental mapping and X-ray studies can be carried out both separately and simultaneously.

Sample positioning accuracy is 10 microns.

The minimum diameter of the x-ray probe is 30 μm .

The range of simultaneously measured elements from ^{11}Na to ^{92}U .

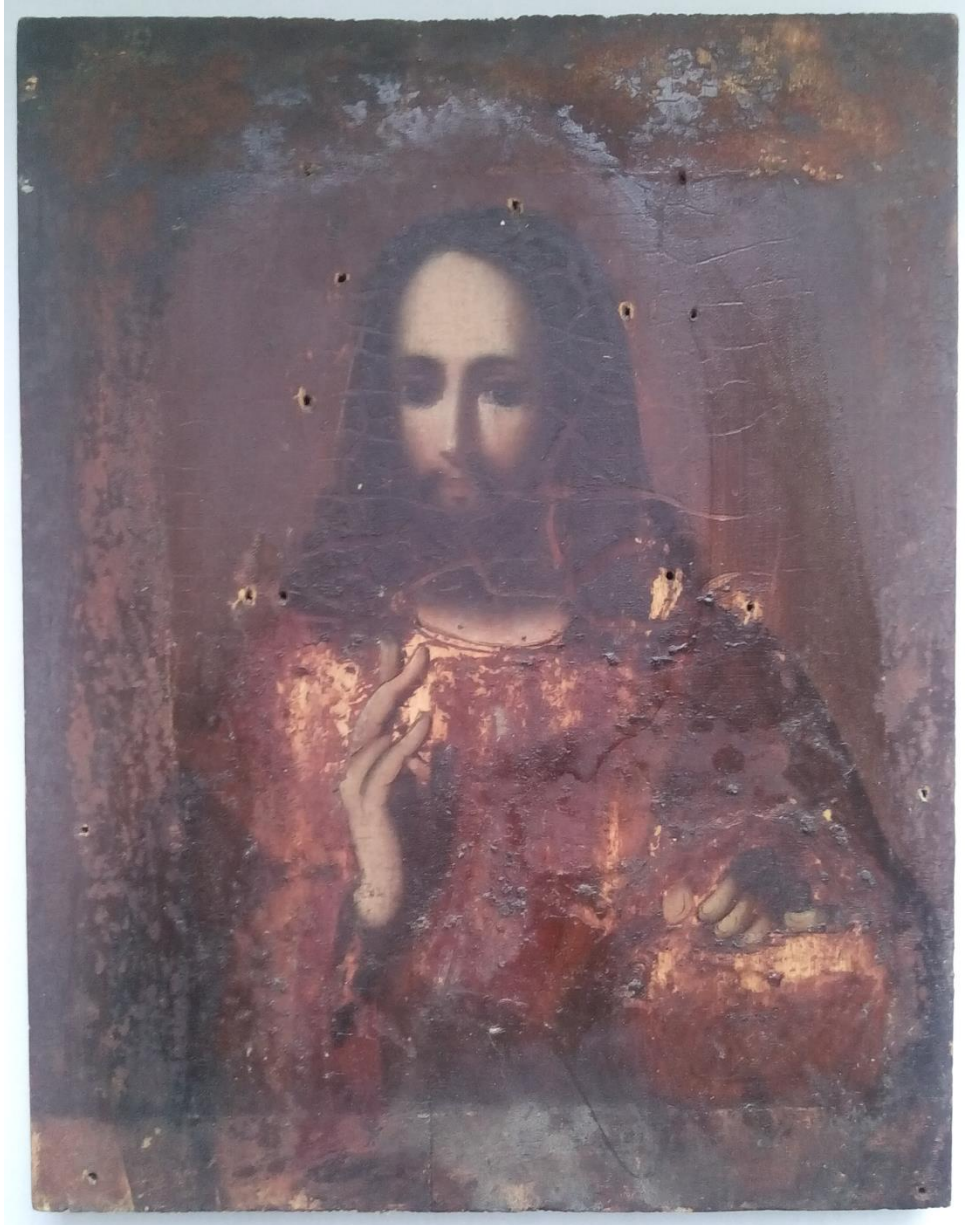
Experiment #1

Small holes on the first icon appeared as a result of attaching the icon frame to it. The frame was removed for analysis.

From the distribution of copper it is clear that the frame was nailed to the icon with copper nails – there is an increased copper content near the holes. The distribution shows how copper over time diffused into the wood on which the icon was painted.

Experiment 1

Scan step	400 μm
Scan rate	400 μm/s
Measurement time	1 000 ms
Voltage	45 kV
Electric current	5 000 μA
XRT	Mo anode
Atmosphere	Air

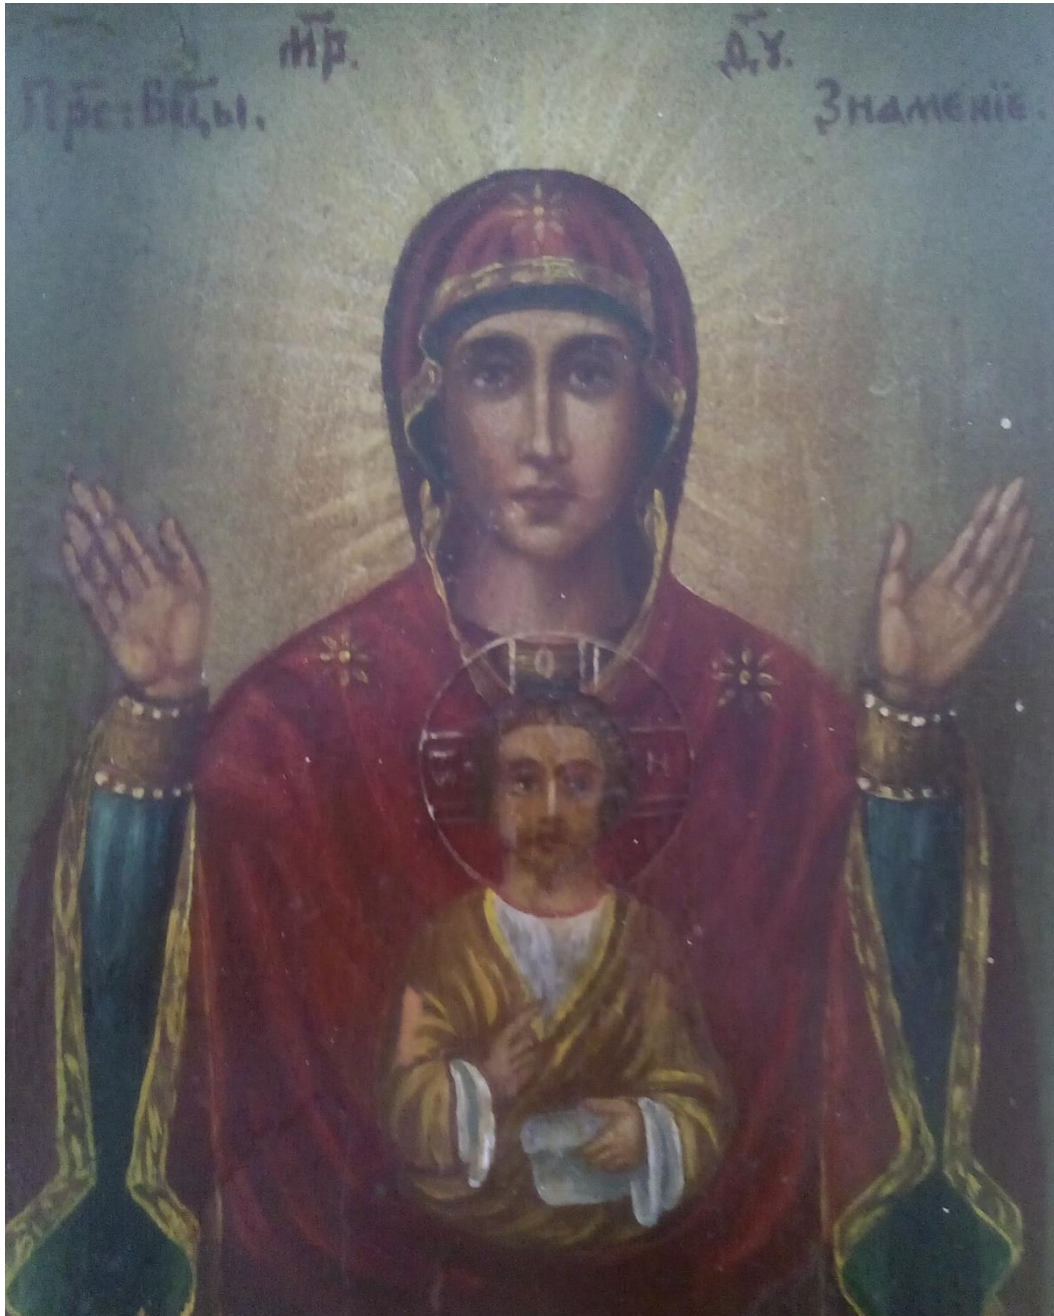
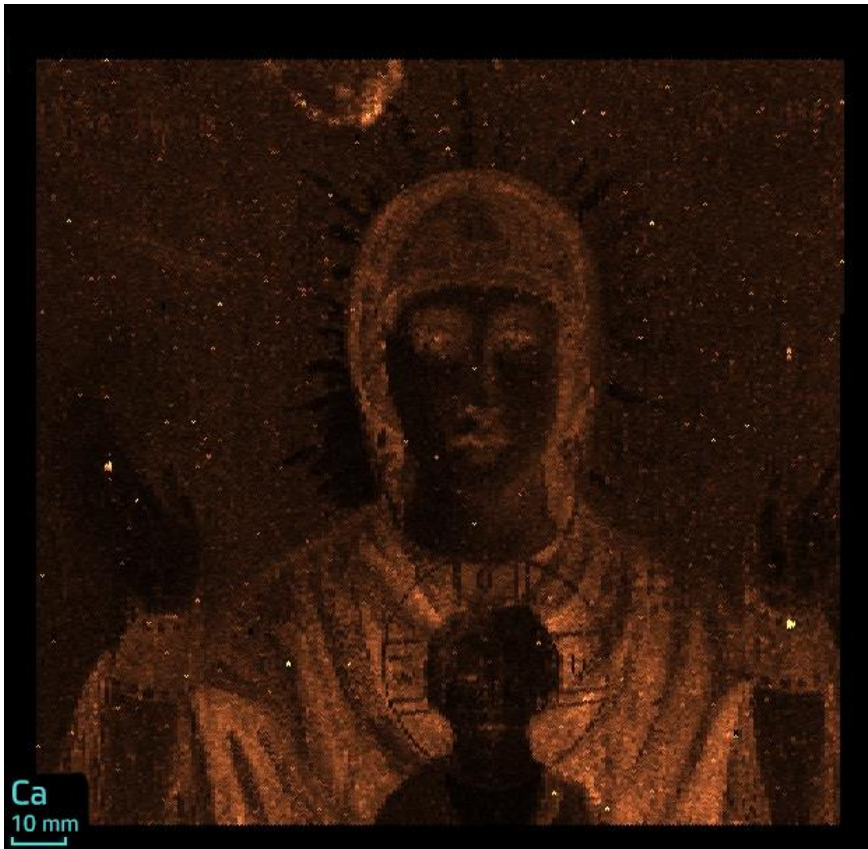
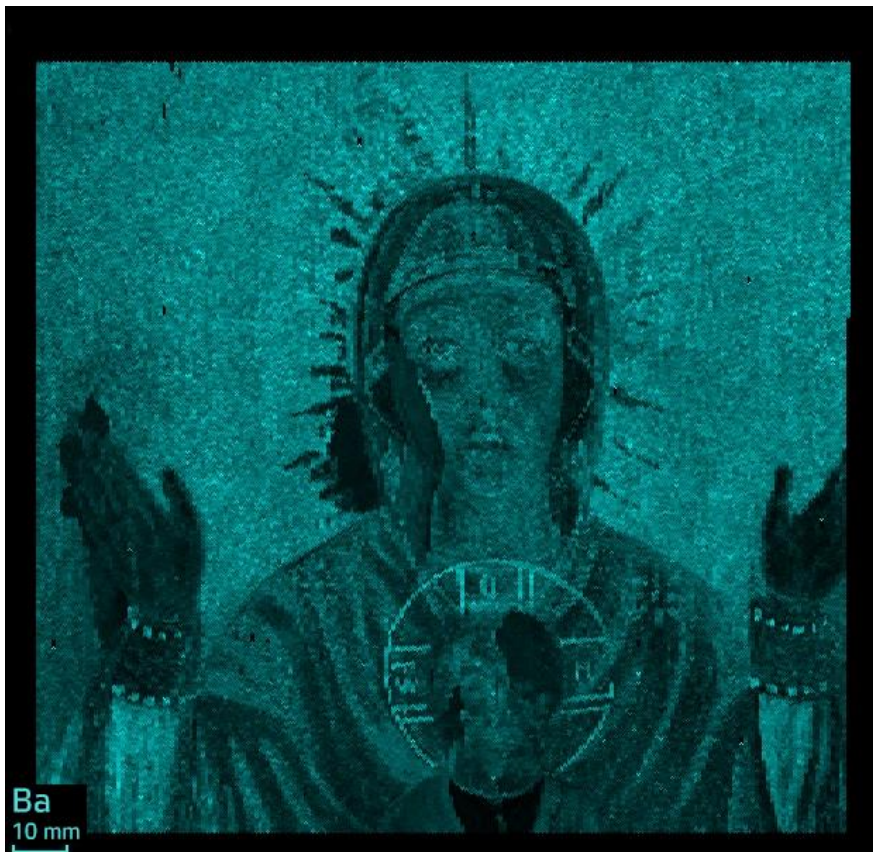
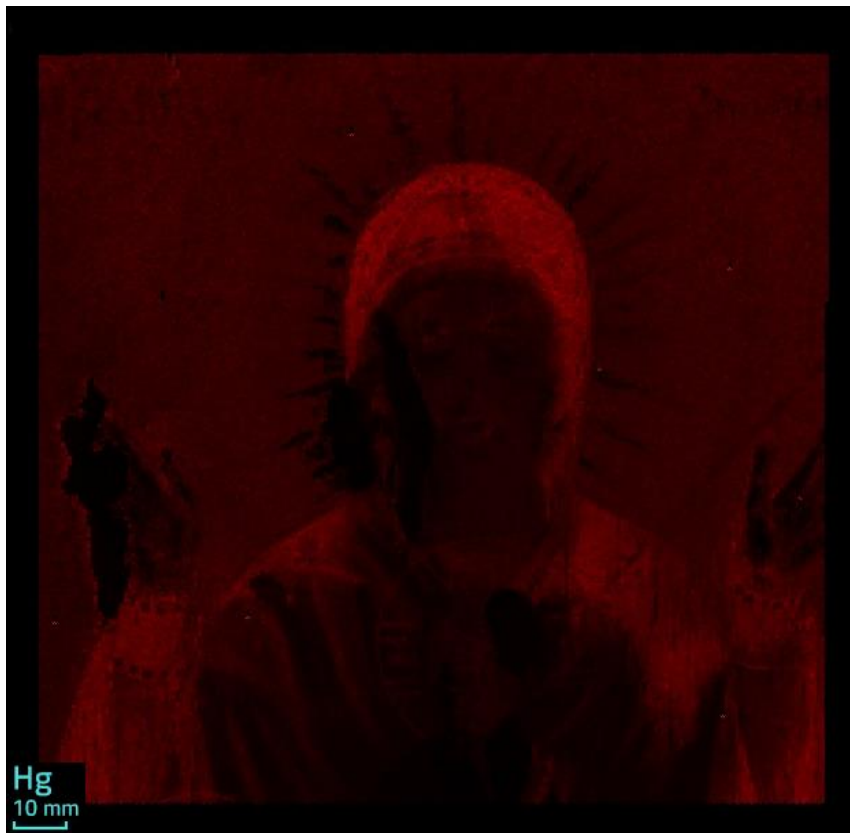
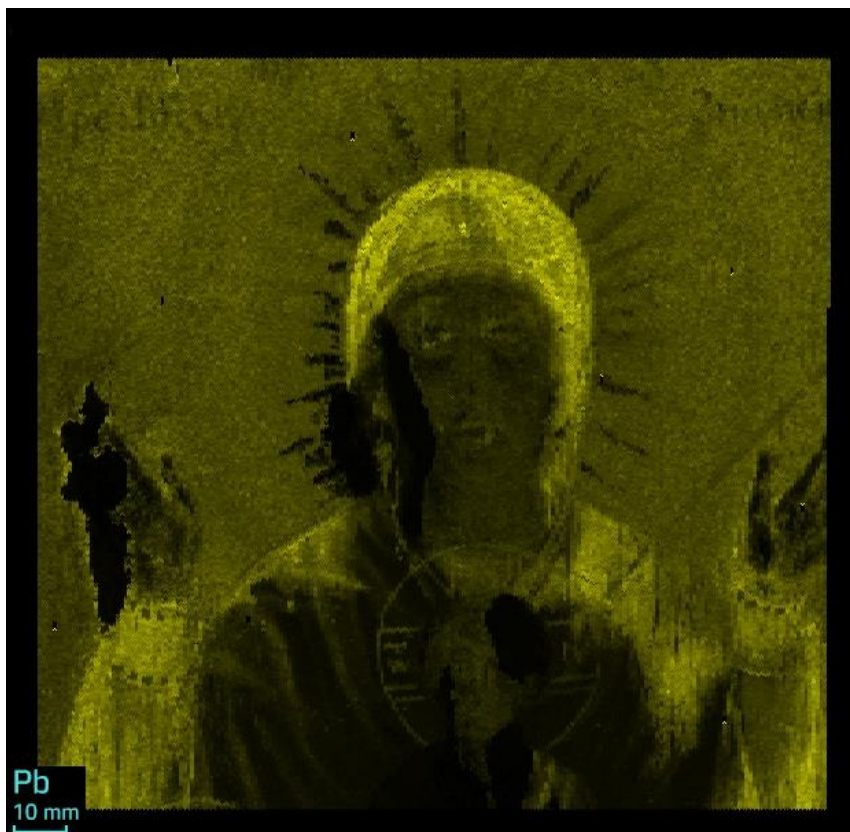
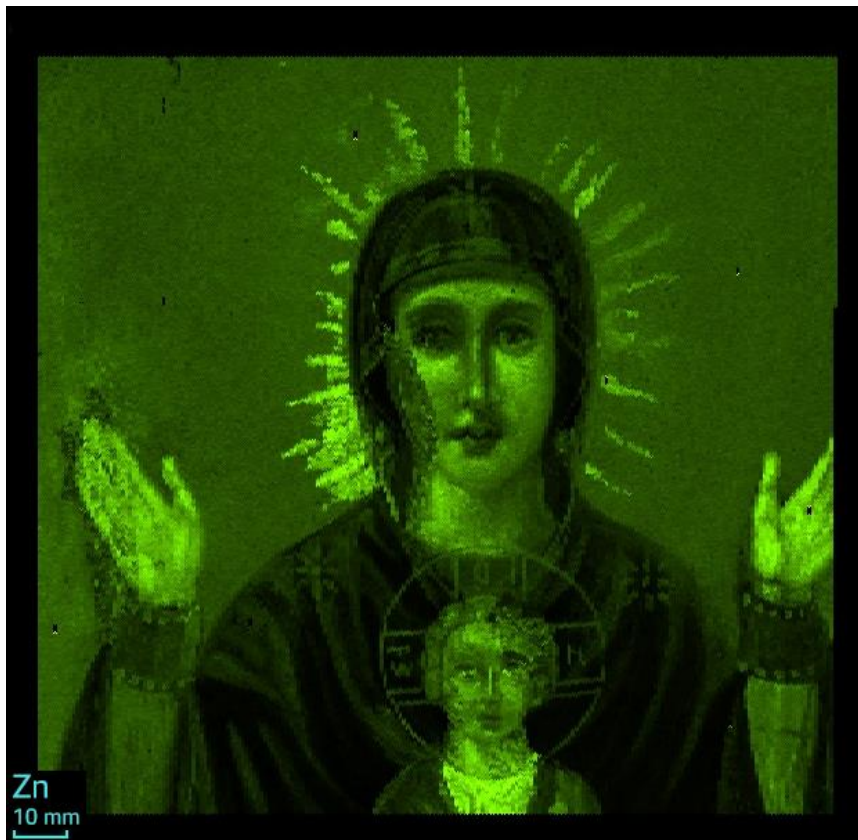
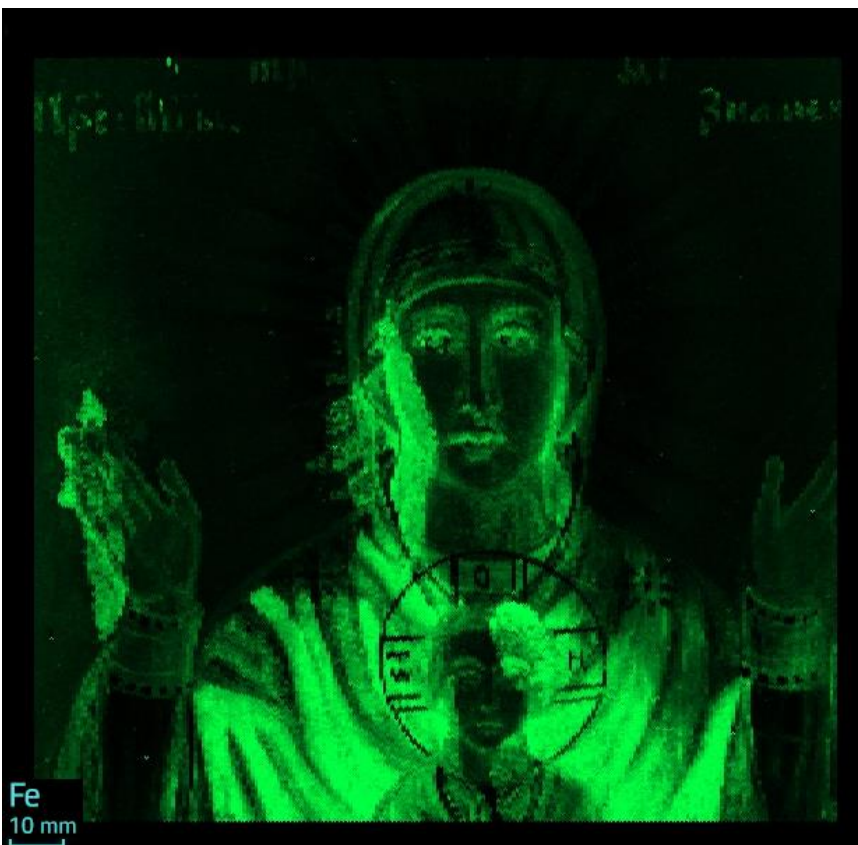
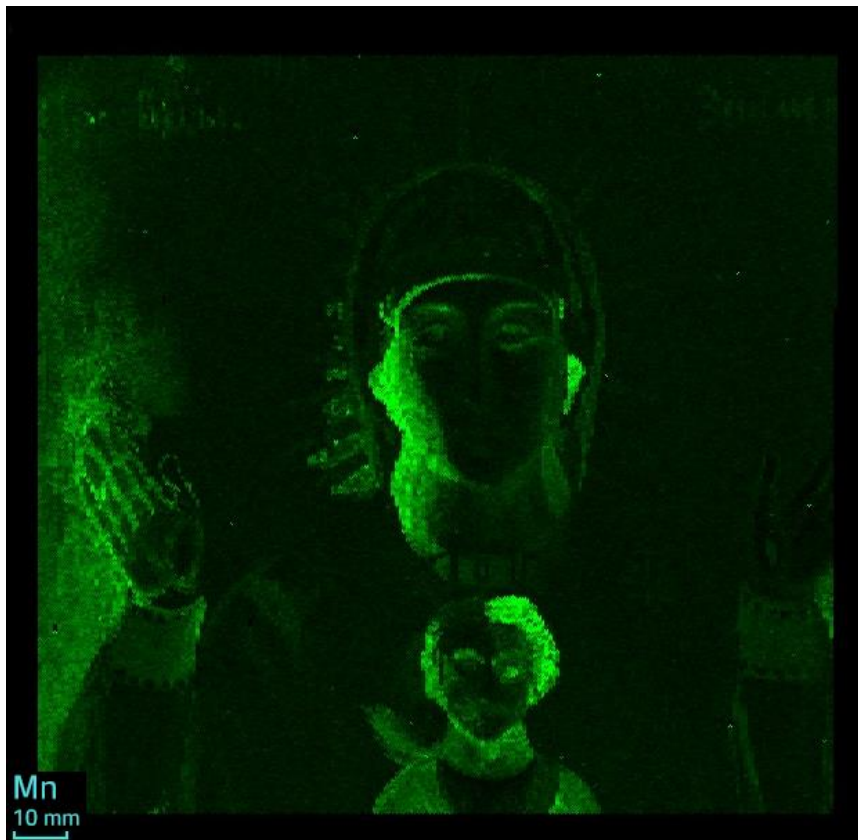
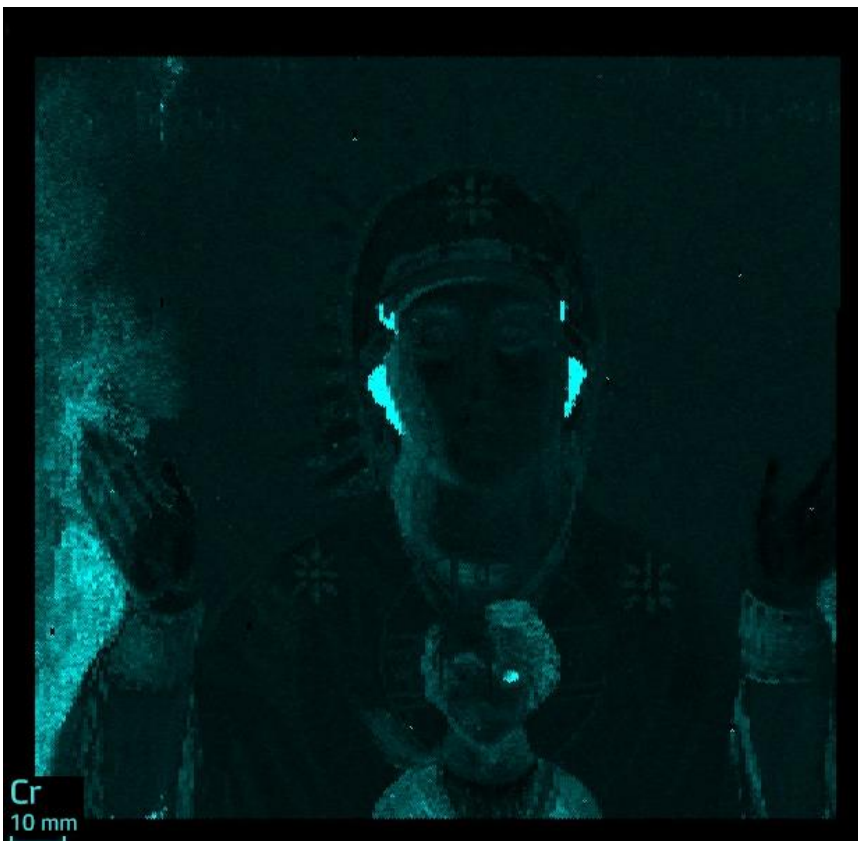
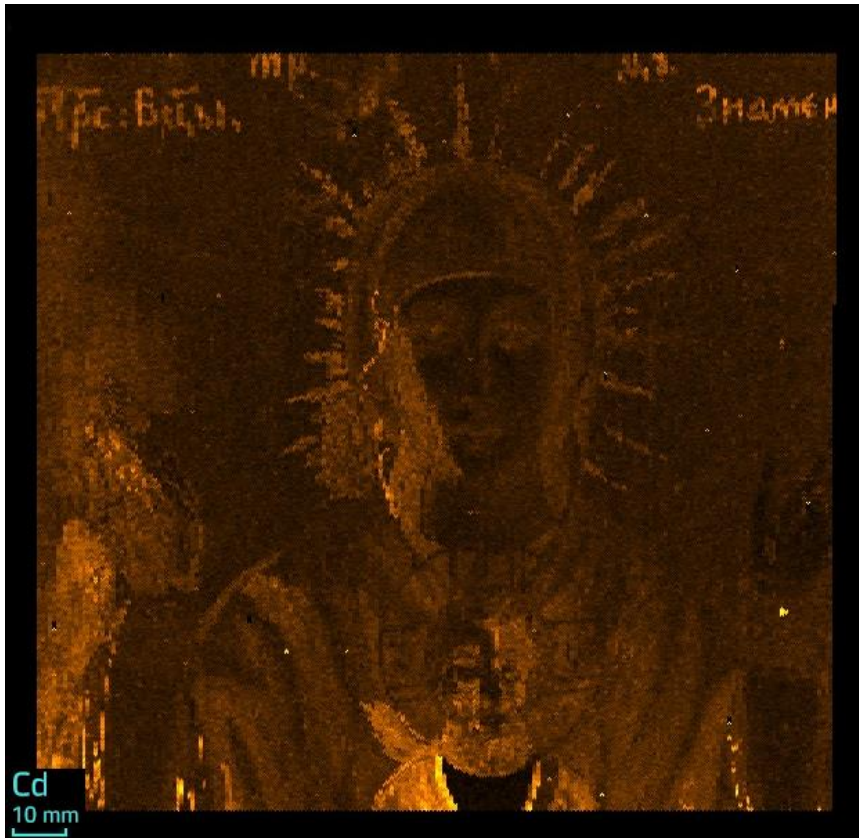
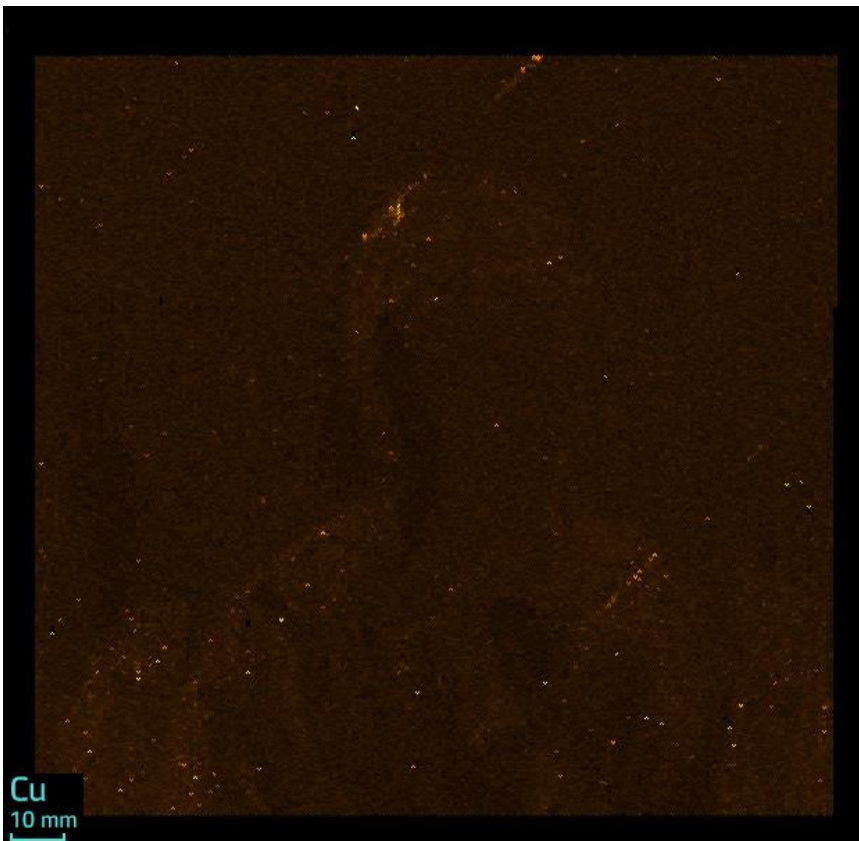
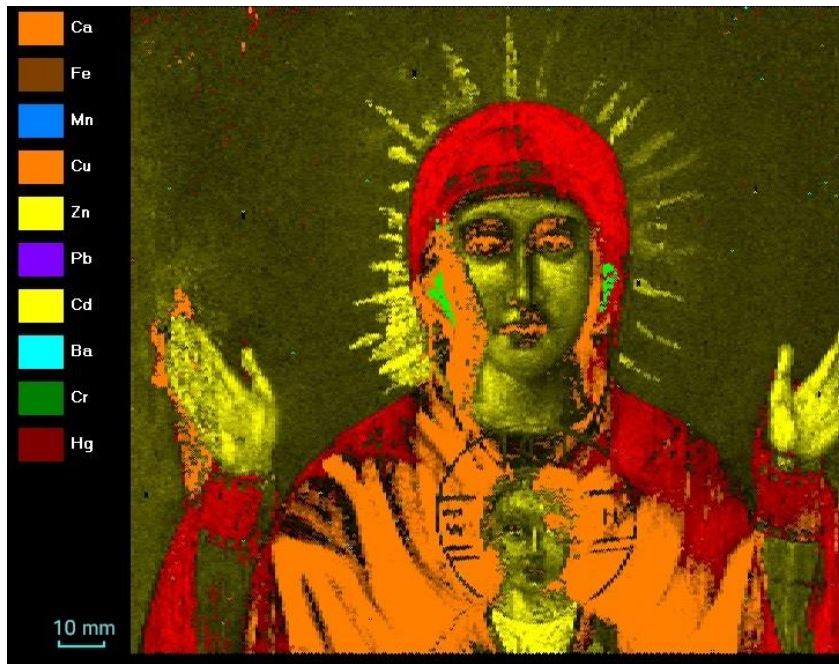
Experiment #2

On the distribution of calcium visible outlines of the figure of the Mother of God. It can be assumed that calcium is a part of paints.

On the left hand, on the left on the face of the Mother of God and on the right on the face of Jesus, you can see areas that lack plumbum, mercury and barium.

Comparing the data on all elements, it is possible to determine the sequence of applying layers of paint, as well as the course of further restoration work.

At first there was a precoating containing barium.

Then the figure of the Mother of God was drawn (contains in colors mercury, plumbum). Then, in places where the paint was peeling off, the background was restored with paints containing iron, chromium and manganese. They re-painted the figure: the dress of Our Lady with paints with iron, the sleeves with barium and zinc. Left hand painted with zinc paint. It should be noted that despite the absence of visible defects on the right hand, it was also redrawn. Cadmium and chrome are present in the colors of Jesus's garment, and zinc in his shirt.

Then the boy's nimbus is painted with barium, zinc and iron paints, and the nimbus of our Lady is painted with zinc paints. The inscription above is painted with cadmium.

The dotted presence of copper may indicate the use of a copper frame: copper particles diffuse into paint and wood over time.

Experiment 2

Scan step	700 μm
Scan rate	700 μm/s
Measurement time	500 ms
Voltage	30 kV
Electric current	6 000 μA
XRT	Mo anode
Atmosphere	Air

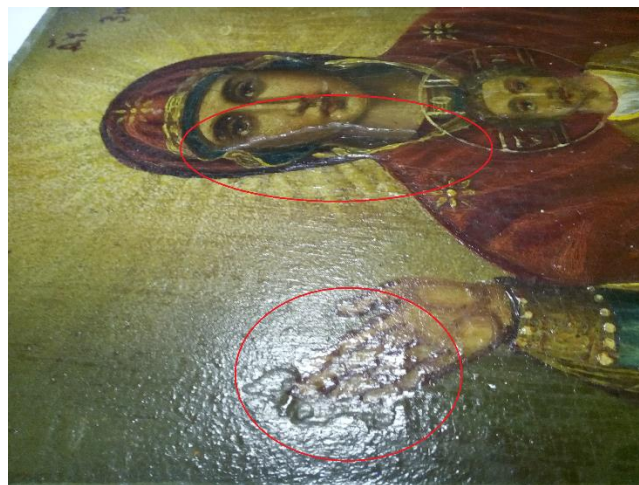
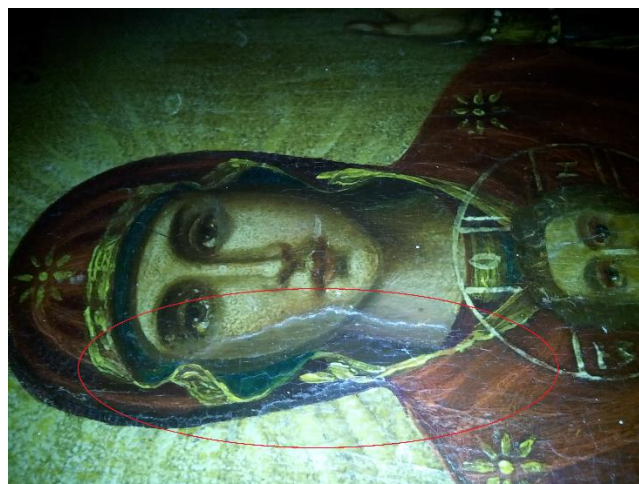
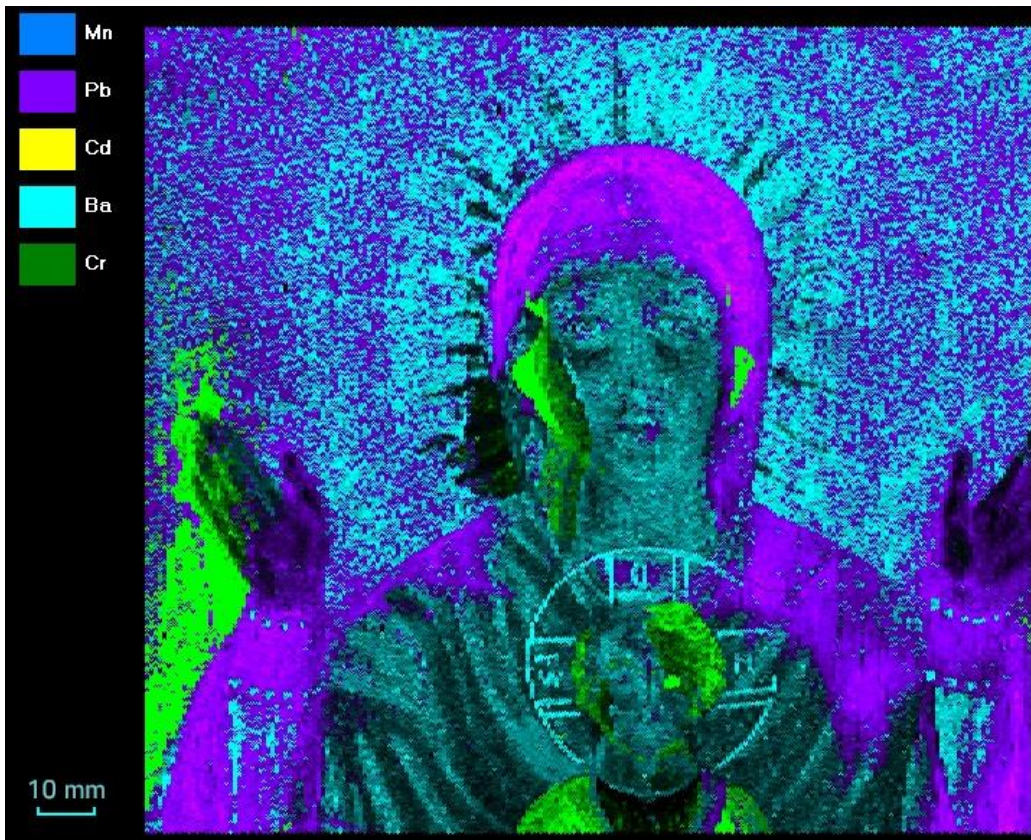
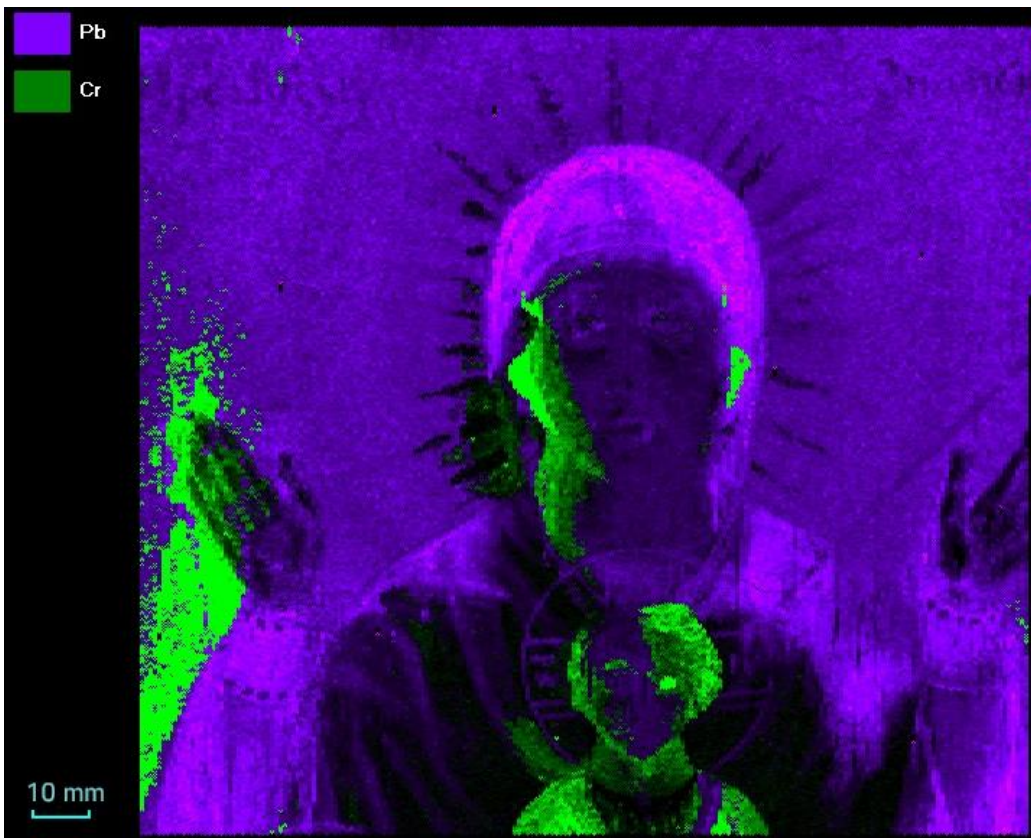
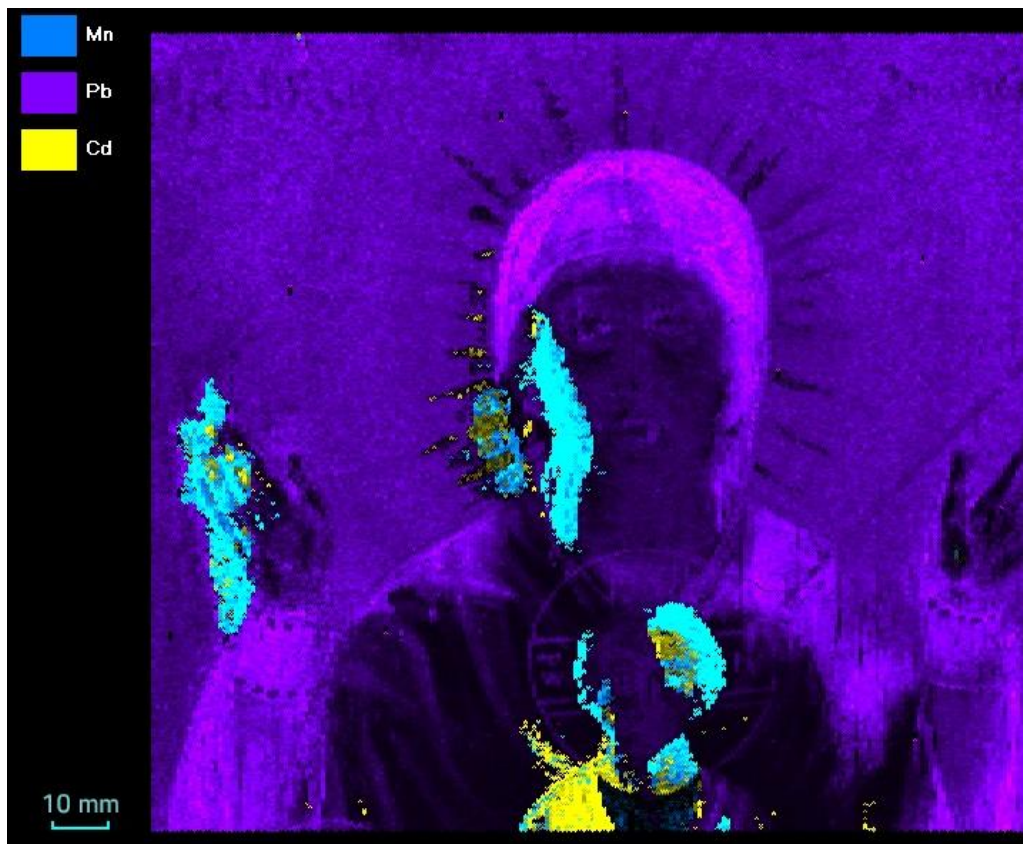
The second icon shows defects in the paint layers.

Defects in the paint layers of the icon are shown below.

The photographs of the icon show defects in the layers of paint on the hand and face of the Mother of God. It is assumed that in these areas the paint was lost and it was restored. Probably, the boy's face was also restored, although the defects on the icon are not visualized.
