MicroXRF analysis of the horse harness fragment

XROS MF30 – laboratory x-ray microscope-microprobe for studies of the objects by the methods of the optical microscopy, radiography, local element XRF microanalysis with possibility of the element mapping. Using a microscope, a sample of up to 400 mm in size along the Y axis and of unlimited size along the X axis (max. scan area 150×150 mm; in the case of a larger area, the scanned areas can be stitched) and up to 105 mm high can be performed.

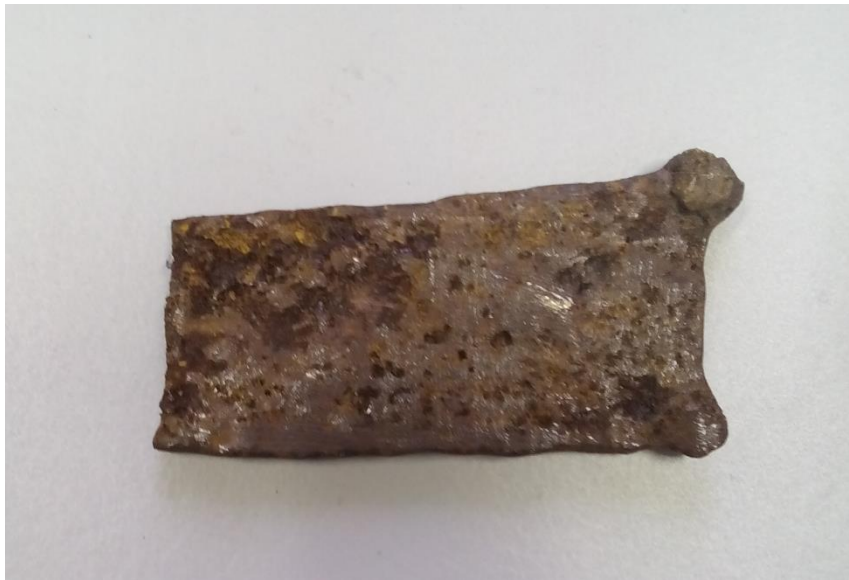
Fig. 1. Photo of a link of a nomad belt

Fig. 1 shows the appearance of the link. Fig. 2 shows the selected scan area. Fig. 3-12 show elemental mapping of the selected area of the sample. Fig. 13 shows the picture of an onlay fragment before and after restoration.

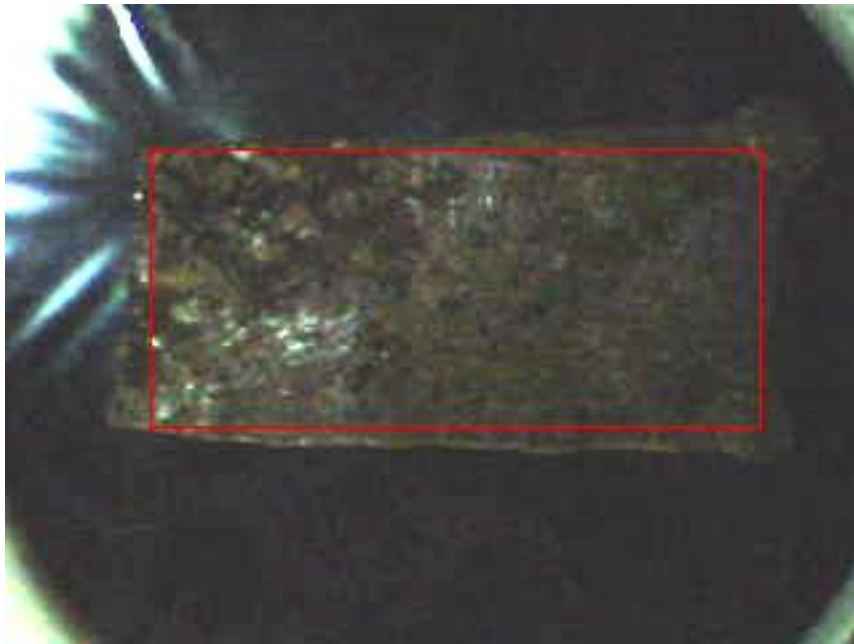
Fig. 2. Belt link. Red highlights the scan area

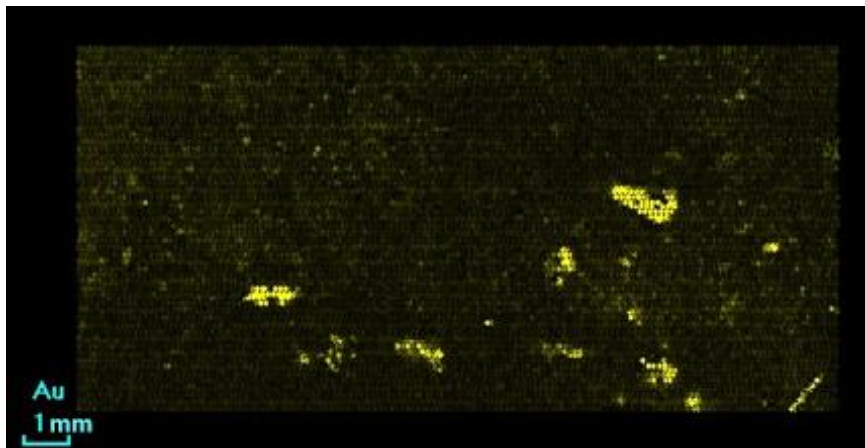
Fig. 3. Distribution of gold

Mapping of other elements also provides meaningful information. Firstly, on the surface of the foil there is gold (Fig. 3). Its small amount is unevenly distributed over the surface. For a better understanding, local distribution of gilding layer on the ornament is shown very clearly on the combined gold and silver map (Fig. 11). Silver foil was apparently gilded to make an ornament of golden color that we see after the reveal. For restoration not only the presence of the ornament has to be determined, but traces of gilding before the start of the reveal are also of great importance. After all, the thinnest gilding, more so unevenly preserved, can be damaged during reveal, unless noticed in advance. Secondly, the presence of copper (Fig. 5) can be connected to using gold as raw material for gilding. Thirdly, the distribution of calcium and silicon (Fig. 6 and 7), can be attributed to contamination with soil, because the object is of archaeological origin. The rest of the elements can also be attributed to random impurities.

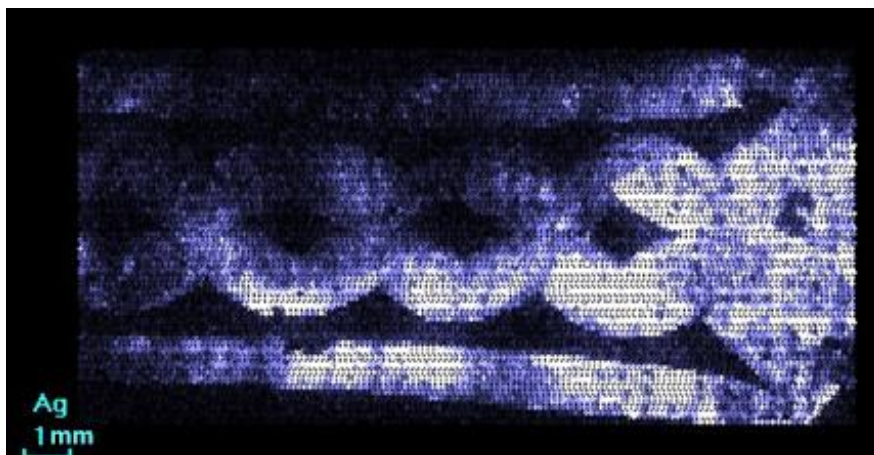
Fig. 4. Distribution of silver

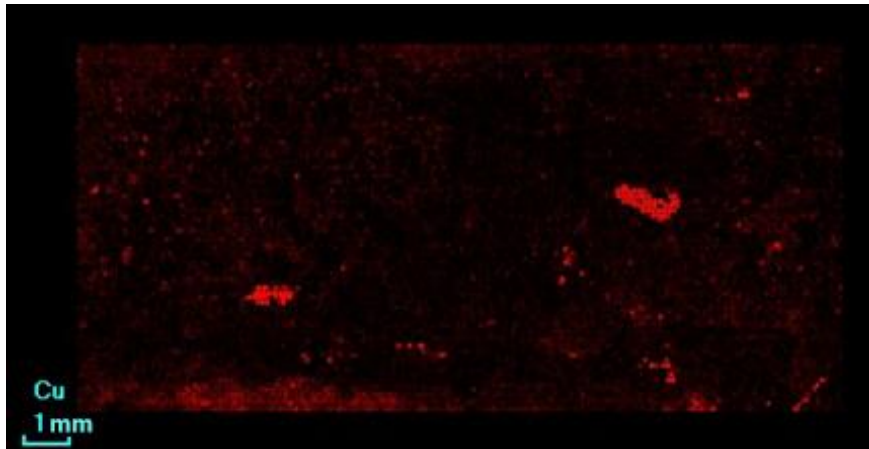
Fig. 5. Distribution of copper

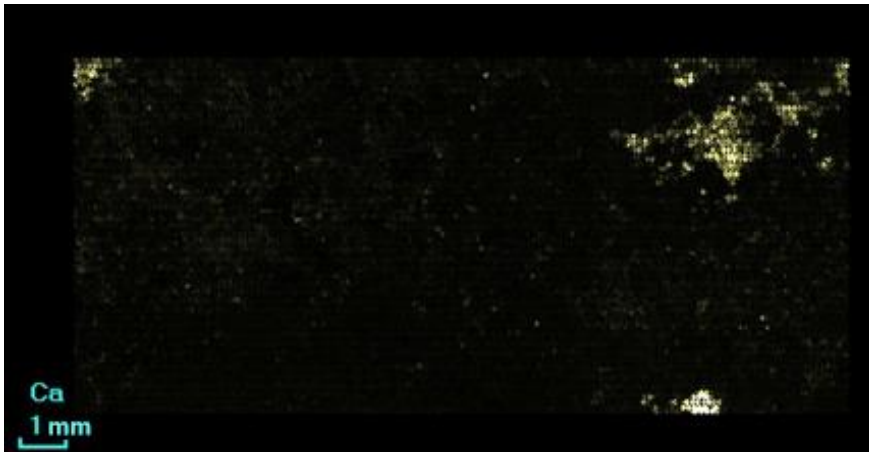
Fig. 6. Distribution of calcium

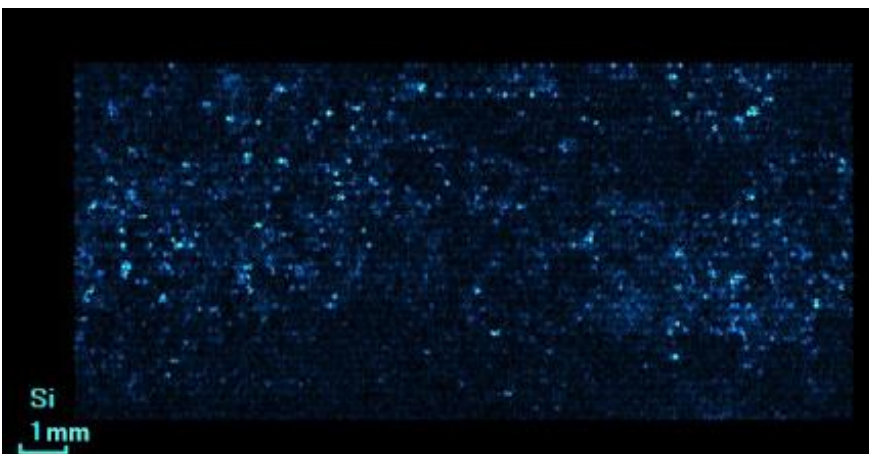
Fig. 7. Distribution of silicon

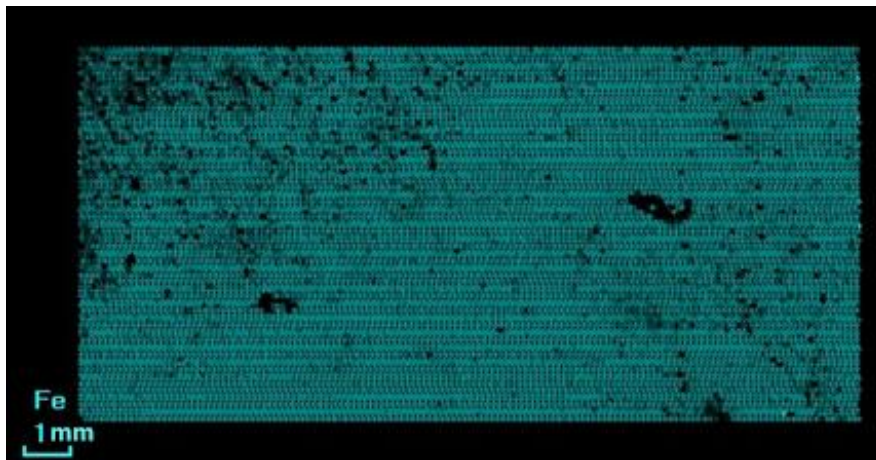
Fig. 8. Distribution of iron

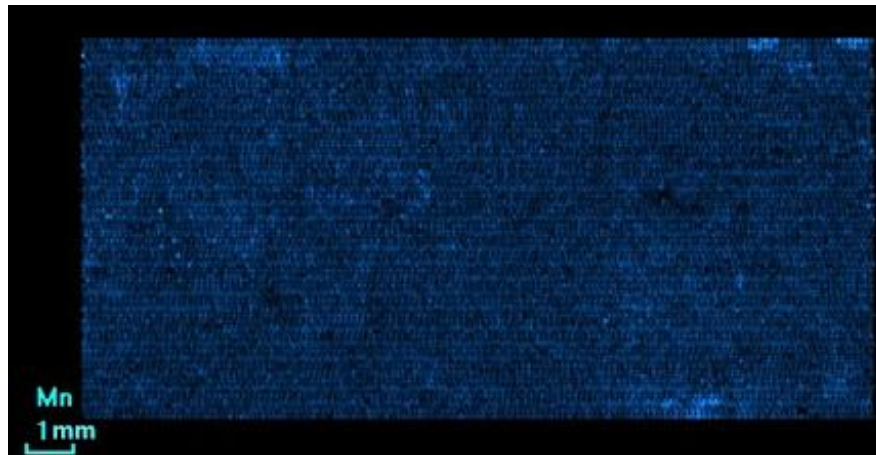
Fig. 9. Distribution of manganese

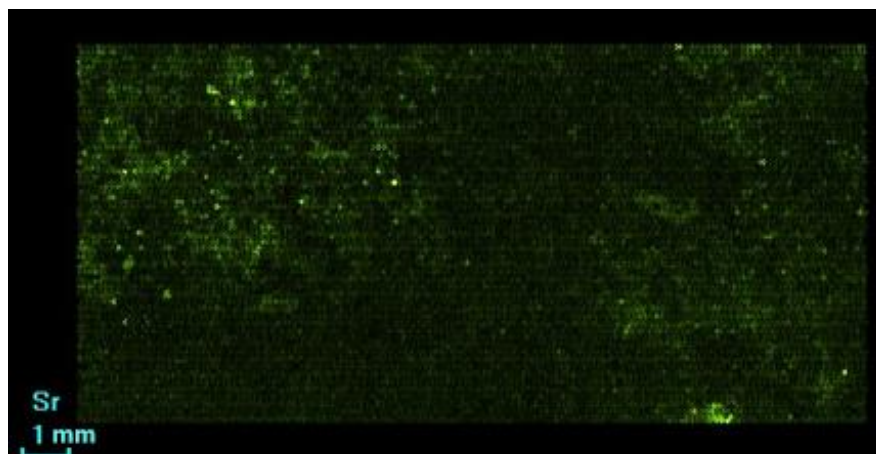
Fig. 10. Distribution of strontium

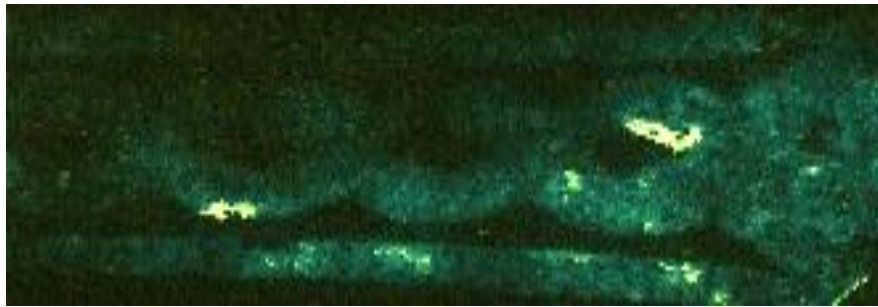
Fig. 12. Distribution of silver (green) and gold (yellow)

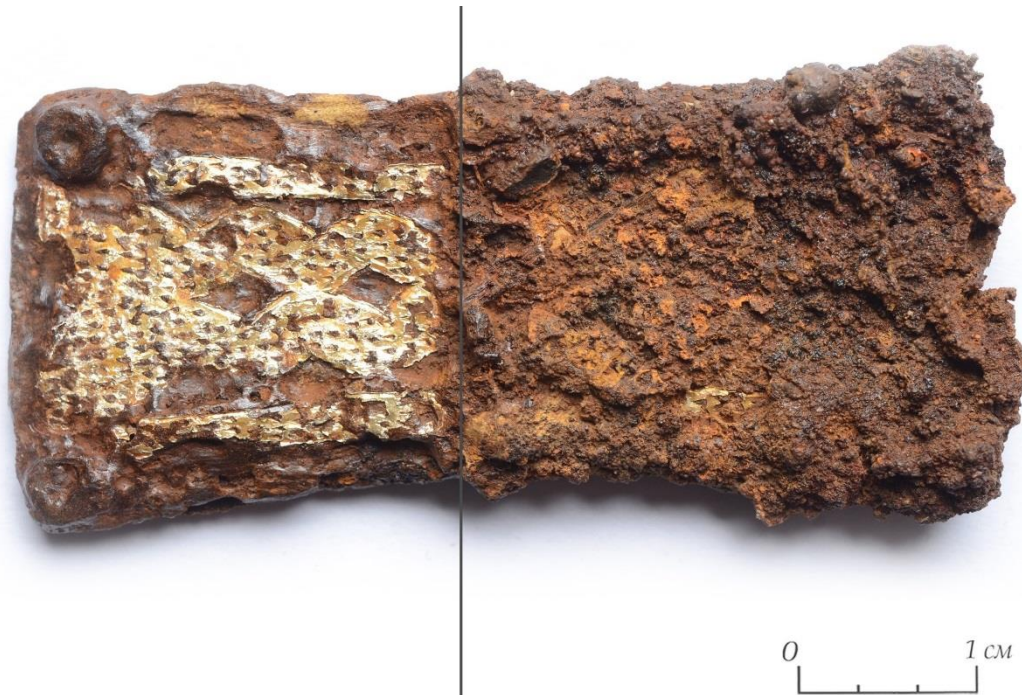
Fig. 13. Harness belt onlay. On the right – mineralized iron layers conceal the ornament completely. On the left – inlay revealed by restoration
